Damage Evaluation of Reinforced Concrete structures at lap splices of tensional steel bars using Bonded Piezoelectric Transducers

Using bonded piezoelectric transducers (PZT), this study evaluates damage to reinforced concrete beams at lap splices of tensile rebars. Four reinforced concrete beams with a span of 2700mm and a cross-section of 200 x 250mm were cast and simply edge-supported on roller supports 2250mm apart. In the zone of constant moment, the tensile reinforcements of the beams were spliced with varying lap lengths (10 ϕ , 20 ϕ , 30 ϕ and 40 ϕ). Two PZT patches (one to operate as an actuator and the other as a receiver) were bonded on steel rebars and placed 50mm apart from their lapping edges. The wave propagation technique was used to record the signals experimentally, and the signals were processed further using wavelet packet analysis. By setting the time lag results of waves under pulse excitation, the damage of beams were identified. Damage indices were calculated based on the wavelet packet energy to ascertain the damage levels. The PZT was very sensitive to detect the pull-out bond failure and ductile flexural failure at the lap slices of steel rebars in the b

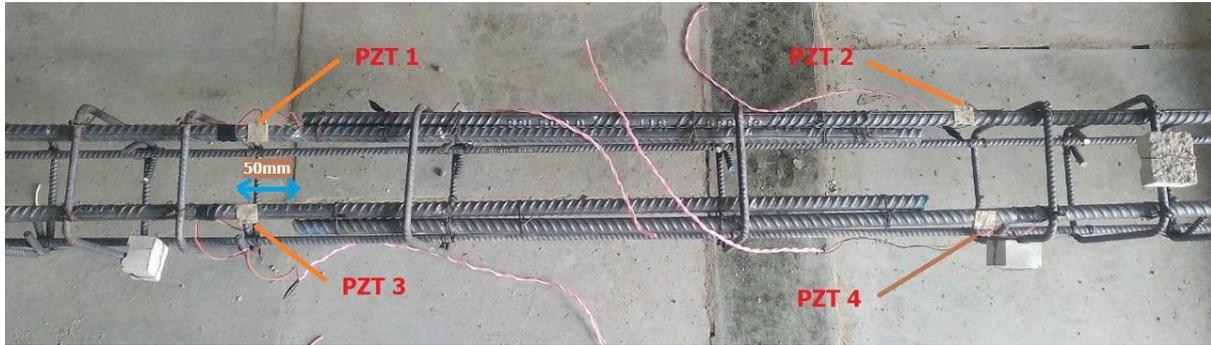
Figure 1 Mounted PZT patches in the spliced rebars

This study focuses on the damage detection of the Reinforced Concrete beams at the lap splices of steel bars using PZT. To detect the damages on reinforced concrete structures at lap zones of steel bars, the PZT were mounted on steel bars with different lap lengths. Tests were performed in four reinforced concrete beams, where the tensile reinforcements of each beam were spliced with varying lengths of the lap of 10 times the diameter of a bar (10ϕ), 20 times diameter of a bar (20ϕ), 30 times diameter of a bar (30ϕ) and 40 times diameter of a bar (40ϕ) in the constant moment zone. Two PZT patches were mounted separately on each steel rebar (B1&B2) at lap splices; one PZT acted as an actuator to generate elastic waves which is then converted as electric signals and recorded by another PZT patch that acts as a sensor. The recorded signals were analyzed using wavelet packets as a signal processing tool.

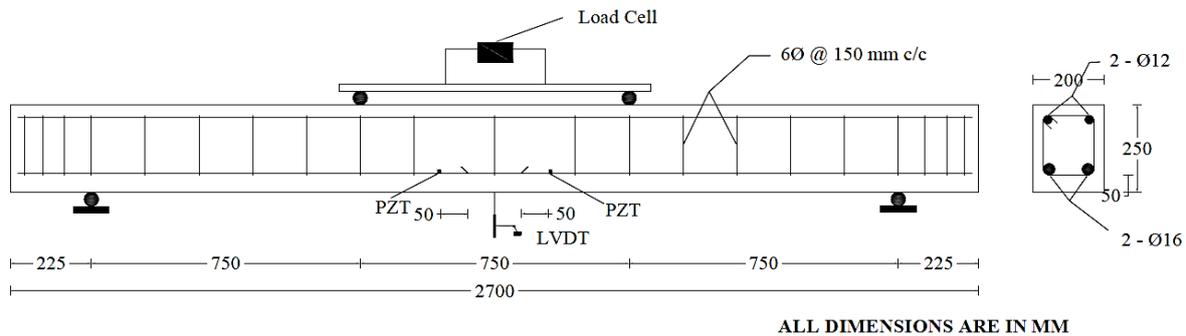
Figure 2 Reinforcement detailing of RC beam

Four concrete beams were tested with high-grade steel bars spliced in the constant moment region, with the objective of initiating failure in the tension zone. The RC beams were cast as a singly reinforced rectangular section with a cross-section of 200mm x 250mm and a length of 2700mm. It was simply supported and subjected to a four-point bending test. As illustrated in Figure 1, two high-grade steel deformed bars of 16mm diameter were used as tension

reinforcement and two numbers of 12mm diameter were used as compression reinforcement on all four specimens. The tension reinforcement was spliced with different lap lengths of 10ϕ , 20ϕ , 30ϕ and 40ϕ which were designated as BS10, BS20, BS30 and BS40 respectively.

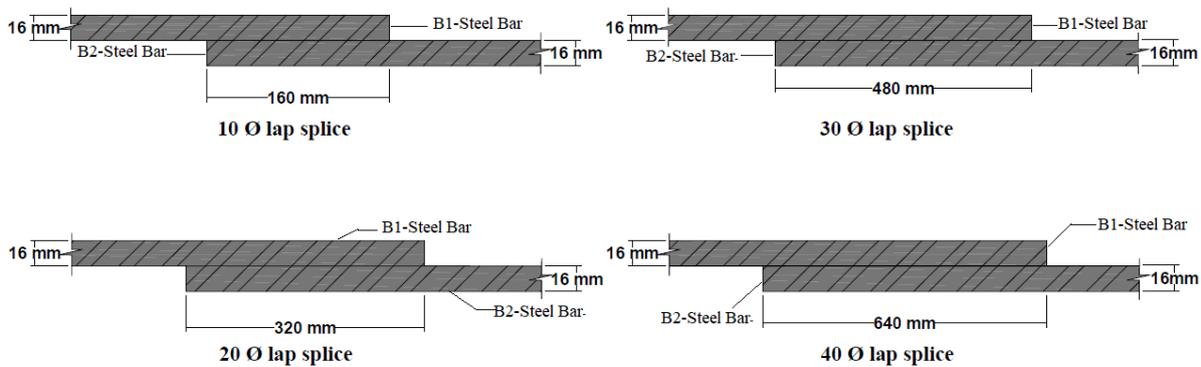
Figure 3 Details of Lap splice

The concrete mix was proportioned with 370kg/m³ of ordinary Portland cement, 185 kg/m³ of water, 814 kg/m³ of sand and 1140 kg/m³ of coarse aggregate with a maximum aggregate size of 20mm and 0.5 of water-cement ratio. The measured compressive strength of concrete was 32 N/mm². Four PZT patches of 20mm X 20mm X 0.4mm dimension (PZT 1, PZT 2, PZT3 and PZT 4) were attached on the spliced bars at 50mm apart from its lapping edges, as shown in Figure 2. On steel rebar, PZT 1 & PZT 3 were utilized as actuators to produce high frequency waves, and PZT 2 & PZT 4 were used as sensors to receive and record the electric signals.They were bonded properly on the steel bar using epoxy adhesive. A fine coating of epoxy coating was provided as a waterproof covering to the installed PZT transducers to prevent damage during concrete casting. The longitudinal section of the beam reinforcement detailing is shown in Figure and the location of installed PZT transducers Figure 3.

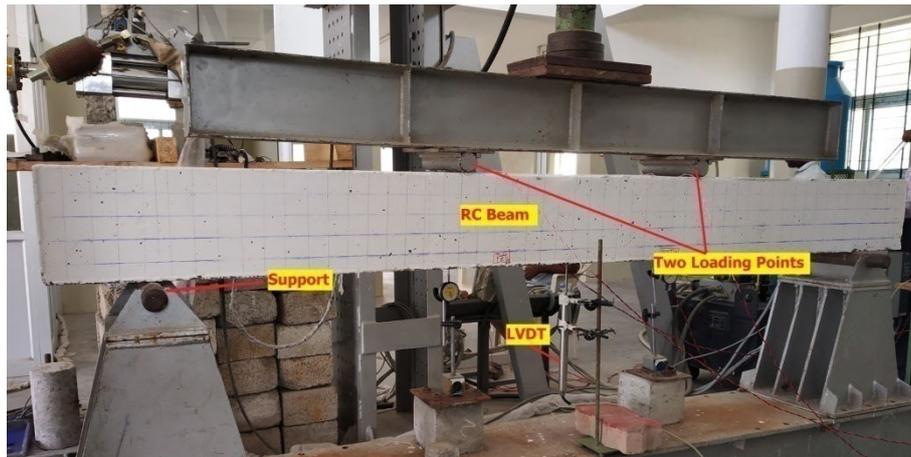
Figure 4 Experimental test set-up of the beams incorporated with PZTs

In this investigation, a cyclic loading paradigm was used. Initially, the structure was loaded to 10 kN and unloaded to 0 kN. After that, the load value was gradually increased and unloaded to 0 kN and continued up to the failure load of 42 kN

for the beam of 10ϕ lap splice, 68 kN for the beam of 20ϕ lap splice, 96 kN for the beam of 30ϕ lap splice and 128 kN for the beam of 40ϕ lap splice. The hydraulic jack exerts load at the centre, distributed evenly at two loading points of the beam, as shown in Figure 4. After each loading, the initiation of crack and its propagation was observed and traced on the surface of the beam to identify the type of failure. The deflections in the centre of the span were measured with a precision of 0.01mm using a Linear Variable Differential Transducer (LVDT). Throughout the tests, load and deflection measurements were continuously monitored and documented. In the time domain, the signals were generated by function generators and recorded by mixed-signal oscilloscopes. Electric signals of 20V magnitude in the form of sweep sine waves were used to actuate the PZT 1 and PZT 3 at the same time. The PZT 2 and PZT 4 transmitted and received elastic waves generated by the PZT 1 and PZT 3. Furthermore, using the experimental set-up established in the SHM technique, measurements of the electric signals in terms of volts were recorded on the installed PZT 2 and PZT 4 of four beams at every cycle loading using the experimental set-up illustrated in Figure 5.

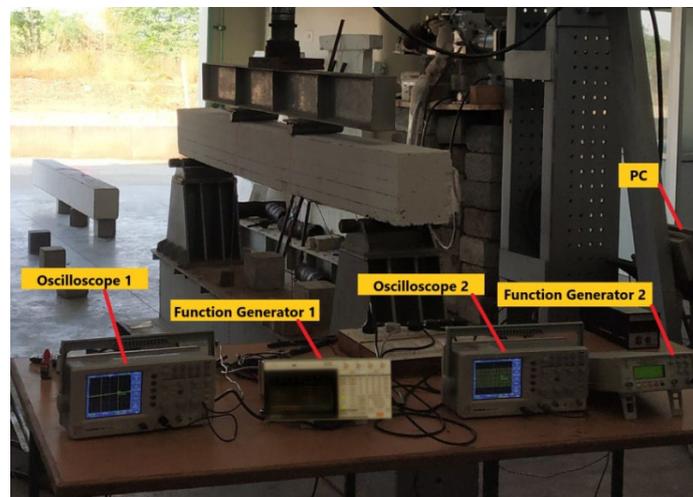
Figure 5 Instrumentation of SHM set-up

The proposed SHM approach was designed to detect possible damage in concrete structures at steel rebar lap splices. The PZT transducer was actuated for a particular frequency range by the arbitrary function generator (Tektronix AFG31000) the transmitted elastic waves and corresponding signals were captured by another PZT. These signals were recorded by a mixed-signal oscilloscope (Tektronix MSO 2000B, DPO 2000B) in the time domain. The recorded electric signals were analyzed using a wavelet packet to quantify the damage levels in the beams at the lap splice zone. The beam specimens were subjected to a cyclic loading paradigm. Before applying the load, the signal measurements were taken in the beam to utilize it as a reference.

Sweep sinusoidal signals were used to stimulate piezoceramic actuators (PZT1 and PZT3) during the loading process, while piezoceramic patches (PZT2 and PZT 4) were used as health monitoring and damage detection sensors. At a sampling frequency of 100 kHz, a sweep sine signal with a frequency range of 10kHz to 100kHz was applied with a signal magnitude of 20 Volts.

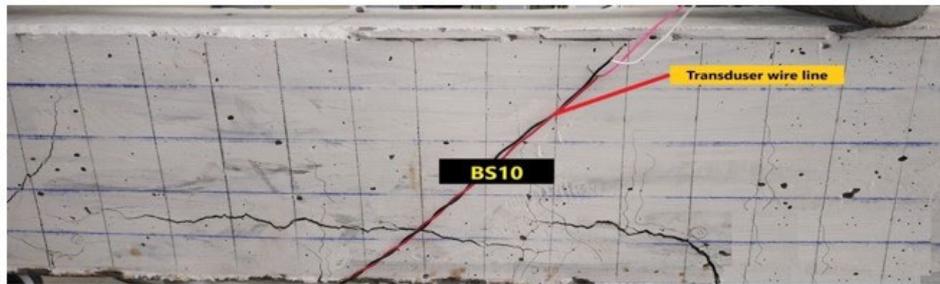
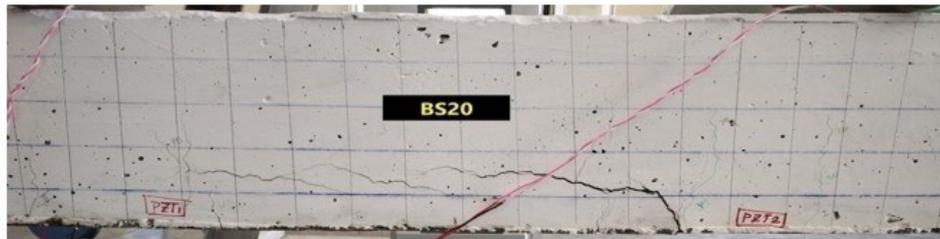
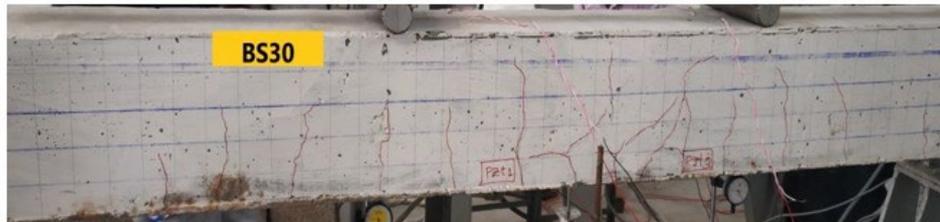
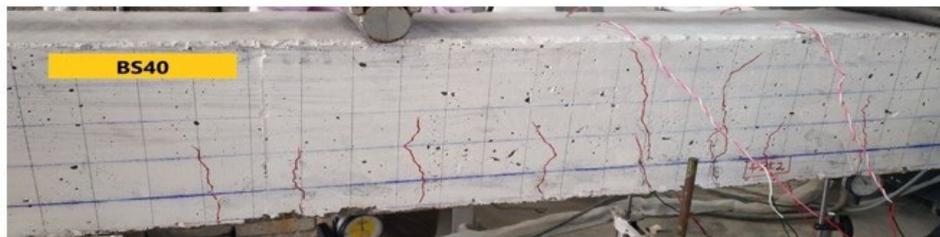
a) Splitting cracks in BS10 Beam

b) Splitting cracks in BS20 Beam

c) Flexural-shear Cracks in BS30

d) Flexural-Shear cracks in BS40

Figure 6 Crack patterns of BS10, BS20, BS30 and BS40

The initiation of flexural cracks in all the beams were observed within the region with constant moment, predominantly occurring in the section of spliced ends as shown in Figure 6. The type of failure, cracking load, ultimate load and corresponding central deflection of the tested beams are provided in Table 1. On increasing the load of the beam, additional cracks were raised within and outside the constant moment region. In BS10 and BS20 beams, the beam specimens of splice length 10ϕ and 20ϕ showed longitudinal splitting cracks initiated at the bottom that extended to the beam's side, as shown in Figures 6(a) and 6(b). A medium splice (BS30) and a long splice (BS40) beams led to flexural failure. In the constant moment area, the cracks started at the bottom and progressed vertically as flexural cracks. Other

than the constant moment area, flexural-shear cracks were noticed.6(c) and 6(d) shows the crack patterns of BS30 and BS40 beams, respectively.

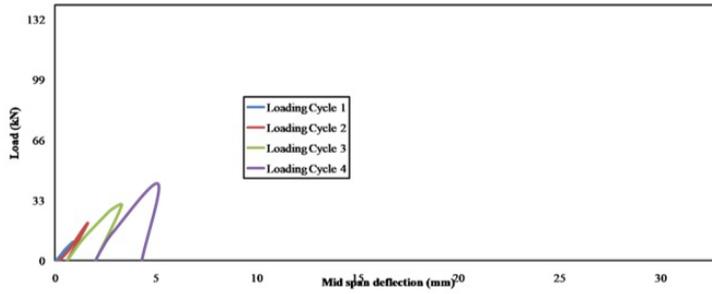
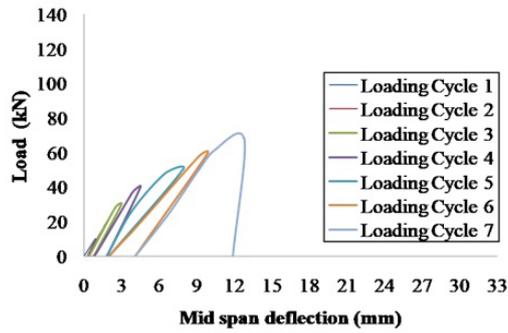
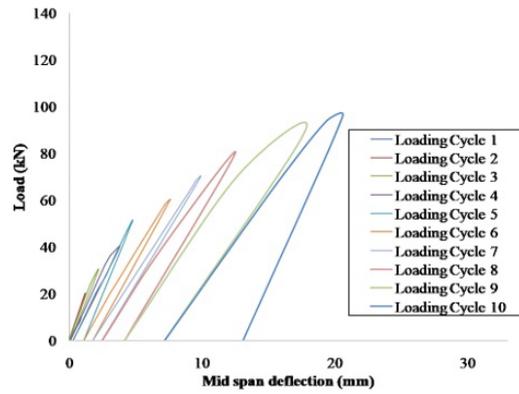
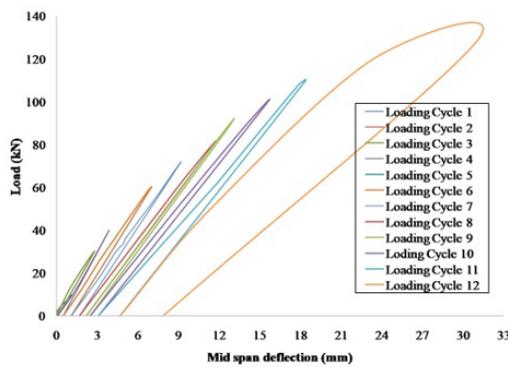
a) BS10 Beam

b) BS20 Beam

c) BS30 Beam

d) BS40 Beam

Figure 7 Loading vs mid-span deflection of BS10, BS20, BS30 and BS40 Beams

Figure 7 presents that with increasing number of cycles and increase in lap length, the bond resistance between steel and concrete at lap splices increases. It was observed that the first two cycles of loading in beams BS10 and BS20 and the first four cycles of loading in beams BS30 and BS40 exhibited flexural-ductile nature. Alike, Figure (a) and Figure (b) show the drastic load drop after reaching the ultimate load in the last loading cycle. This evidence concludes that the beams BS10 and BS20 failed in brittle nature due slippage at bond at lap splices. After the fourth cycle of loading in beams

BS30 and BS40, there was an increase in residual deflection at mid-span. Figures 7(c) and 7(d) illustrate the beam's gradual yielding after attaining the ultimate point.

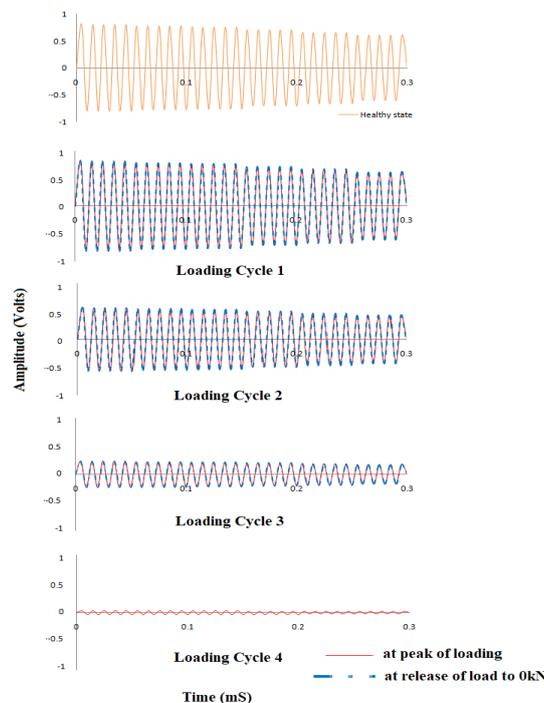
Figure 8 Time domain Response of PZT2 for Beam BS10

The Beams BS10 and BS20 experienced four cycles of loading and seven loading cycles, respectively. The PZT2 and PZT4 were used to record the signals from the excitation of PZT1 and PZT3. Before applying the load on beams, the signals were recorded from the sensors, and they were used as reference signals (healthy state condition). The sensor readings were taken at two points in each loading cycle, one at the peak and the other at the release of load at 0kN. The time-domain plots of recorded signals from PZT2 of beams BS10 and BS40 are shown in Figures 8 and 9.

The output magnitude of the PZT2 sensor decreased with increase in load values. At the initial stages of the loading cycle, the maximum sensor output magnitude of 5.2V was observed in beam BS40, while in the final loading cycle, it was close to 0V. It represented that the reinforced concrete beam gave a good conduit for the propagation of waves in the first loading cycle, but in the final loading cycle, the wave propagation is almost blocked. Therefore, the RC beam was in a healthy state at the first loading cycle and a damaged condition in the final loading cycle.

The variations in amplitudes of sensor measurements between the peak of loading and release of loading to 0kN as in beam BS40 were not found anywhere in the beam specimen BS10 can be seen in 8. It illustrates that the beam BS10 is not having quasi-elastic behavior since it failed in brittle nature.

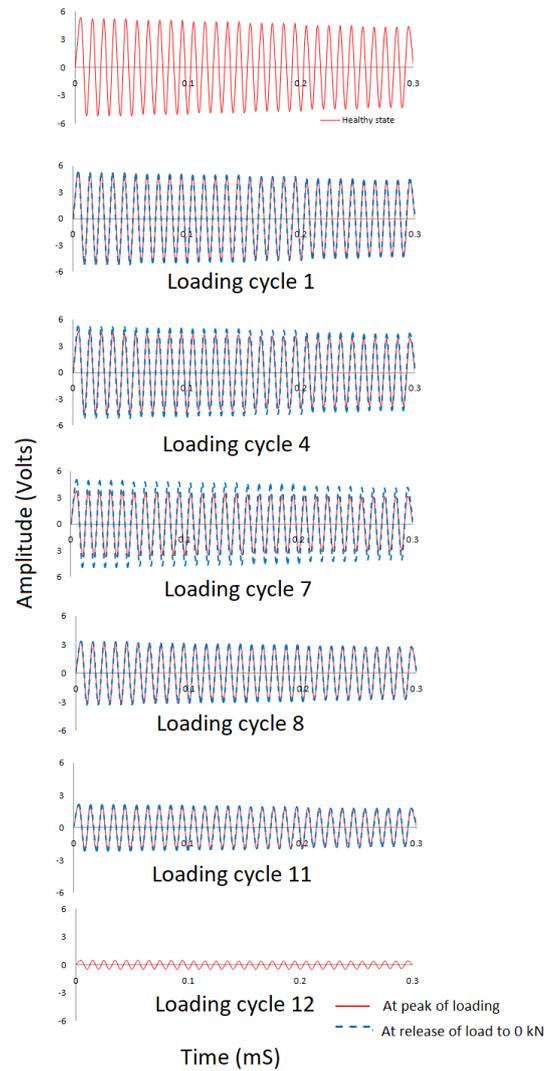
Figure 9 Time domain Response of PZT2 for Beam BS40

It is observed that the amplitudes of sensor measurements vary between the peak of loading and release of loading to 0kN in loading cycles 4 to 7. When the load reached the peak of these cycles, the cracks were opened, and the path of elastic waves was obstructed and scattered. Thus the amplitudes of signals decreased. Subsequently, when the load was released to 0kN, the opened cracks closed and the amplitude of waves increased. It shows that the beam specimen behaved as a quasi-elastic state in the respective loading cycles. After each loading cycle, the new cracks were developed, the old cracks were widened, and hence the amplitude of signals has reduced further.

The abrupt drop in the sensor responses signifies that the sharp increase in the crack width is due to failure in the specimen. Because of the final loading cycle of BS40, there is a plunge in the sensor output mainly due to flexural-shear cracks in the concrete beam. These cracks were observed due to a severe blockage in the propagation of waves.

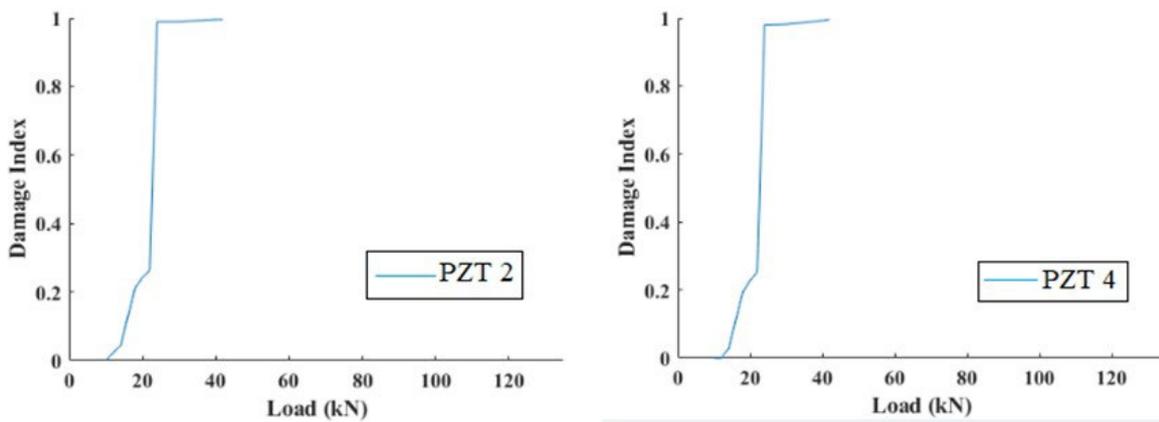
Figure 10 Damage Index Versus Load for the sensors PZT 2 and PZT 4 of Beam BS10

It is apparent from Figures 10 and 11 that the DI values for sensors PZT2 and PZT4 of the beams BS10 and BS20 starts to increase when the load value reaches to 10kN and 16kN, respectively, which indicates that the internal circumferential tensile cracks around the lapped steel bars are initiated and increased further in the concrete. The longitudinal splitting cracks are detected by a microscope when the load values reach 22kN and 28kN, respectively. Therefore, the proposed method is more sensitive since it can sense the internal cracks even before the splitting cracks appear on the beam surfaces.

When the load values reach 24kN and 36kN in the beams BS10 and BS20 (Beams of 10φ and 20φ lap splices) respectively, the DI value for each sensor surpasses its maximum value, followed by a sudden vertical climb of damage index curve from 0.3 to 1 as shown in the Figures 10 and 11. It indicates that the complete splitting and pull-out bond failure occurred in the beams of 10φ and 20φ lap splices, respectively.

The value of damage index 1 shows sensor output as zero, it indicates the cracks blocks all the wave propagation. However, based on the experiment results, it is observed that the structures failed at 42kN and 68kN, respectively. Therefore, the proposed method of SHM is more beneficial to detect the pull-out bond failure of structures where the lap length of steel bars is poorly detailed. Also, it may give an advance indication even before the structural collapse due to brittle failure.

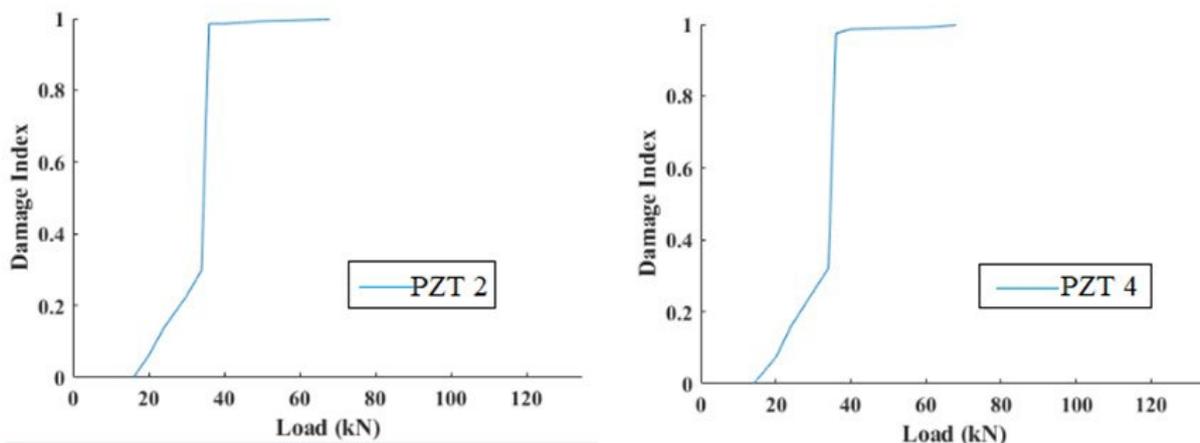
Figure 11 Damage Index Versus Load for the sensors PZT 2 and PZT 4 of Beam BS20

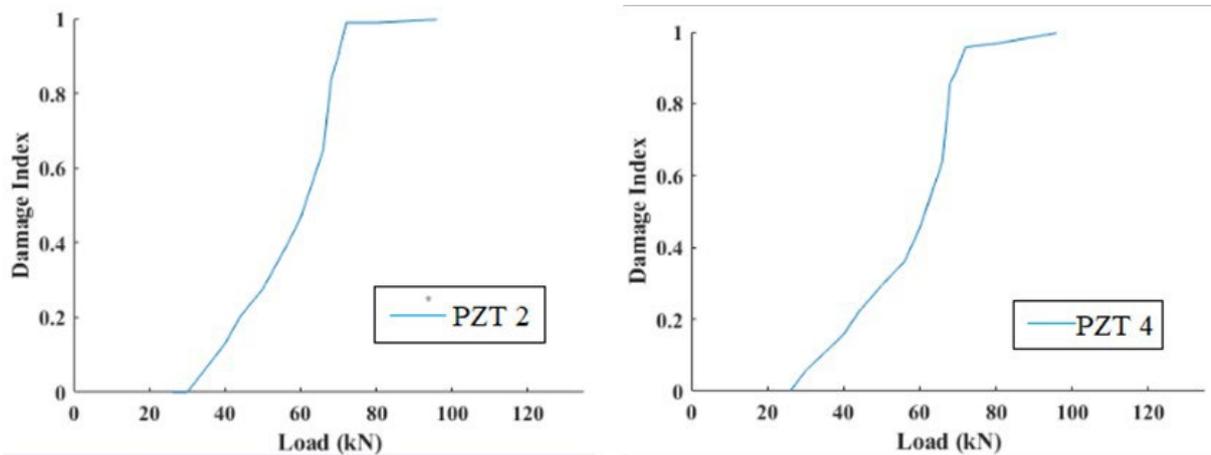
Figure 12 Damage Index Versus Load for the sensors PZT 2 and PZT 4 of Beam BS30

From Figures 12 and 13, the DI values for sensors PZT2 and PZT4 start to escalate when the load value extends to 30kN and 36kN in the beams BS30 and BS40, respectively. It also shows that the DI value rises progressively with the increase of the load, and the maximum DI value of 1 was attained at 72kN and 84kN of the beams, respectively. These indicates that there was an adequate bond resistance developed between concrete and steel bars at lap splices and there was no catastrophic failure of beams BS10 and BS20. However, the complete failure of beams was detected using conventional devices at lap splices only when the load value reached 96kN and 128kN, respectively. Hence the proposed SHM is more sensitive to detecting the damages at lap zones of steel bars in RC structures.

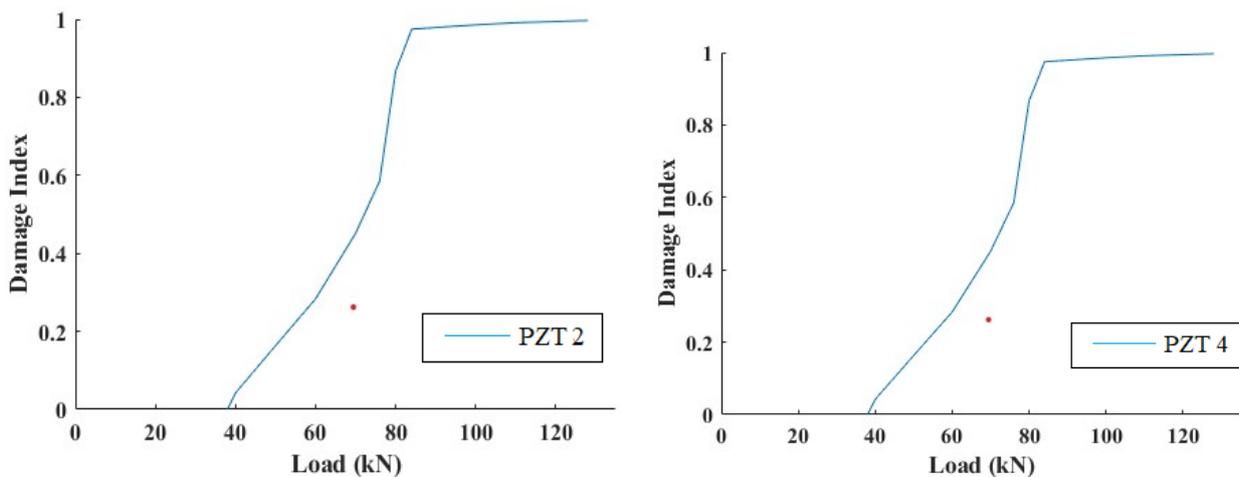
Figure 13 Damage Index Versus Load for the sensors PZT 2 and PZT 4 of Beam BS40
